Contract #: 04-0120F4Cty: SF/ALA Rte: 80 PM: 13.2/13.9File #: 99.28**WELDING INSPECTION REPORT****Resident Engineer:**Siegenthaler, Peter**Address:** 333 Burma Road**City:** Oakland, CA 94607**Report No:** WIR-026374**Date Inspected:** 20-Mar-2011**Project Name:** SAS Superstructure**OSM Arrival Time:** 1500**Prime Contractor:** American Bridge/Fluor Enterprises, a JV**OSM Departure Time:** 300**Contractor:** Zhenhua Port Machinery Company, Ltd (ZPMC) Changxing Island **Location:** Shanghai, China**CWI Name:** Lv Li Qing**CWI Present:** Yes No**Inspected CWI report:** Yes No N/A**Rod Oven in Use:** Yes No N/A**Electrode to specification:** Yes No N/A**Weld Procedures Followed:** Yes No N/A**Qualified Welders:** Yes No N/A**Verified Joint Fit-up:** Yes No N/A**Approved Drawings:** Yes No N/A**Approved WPS:** Yes No N/A**Delayed / Cancelled:** Yes No N/A**Bridge No:** 34-0006**Component:** OBG**Summary of Items Observed:**

WELDING INSPECTION REPORT

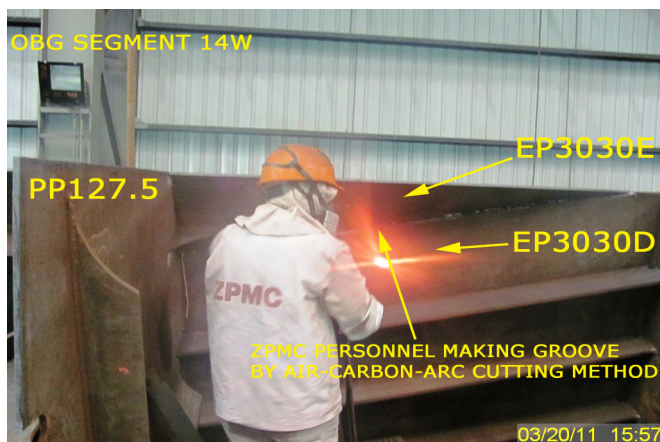
During random in process observations of OBG Segment 14W, this QA inspector observed ZPMC personnel making groove by air-carbon-arc-cutting method on joint located on Edge Plate (EP3030E) to Edge Plate (EP3030D) of OBG Segment 14W. This QA performed Visual Testing (VT) of the joint and found that appeared to be in general compliance with the applicable contract documents. For more details please see attached photo below:
